# The Boys Backstage

Behind the scenes at the Mayflower Theatre, Southampton.

June 1987 Volume 2 No.6

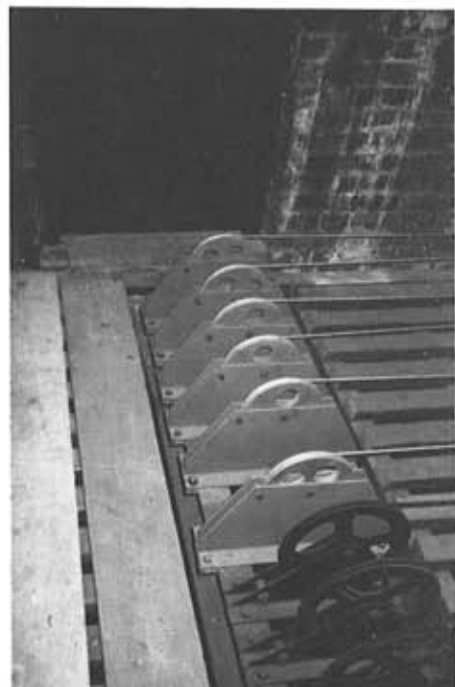
The new counterweight sets.

New scenery pack rails were fitted along the actors left stage area, and there was a total rebuild and overhaul of the safety curtain hoist. All rope locks were overhauled as was the complete counterweight system. Six totally new counterweights designed by Hall Stage were provided as part of the general enlargement and up-dating of the system, as was a flying beam track with an integral motor unit.

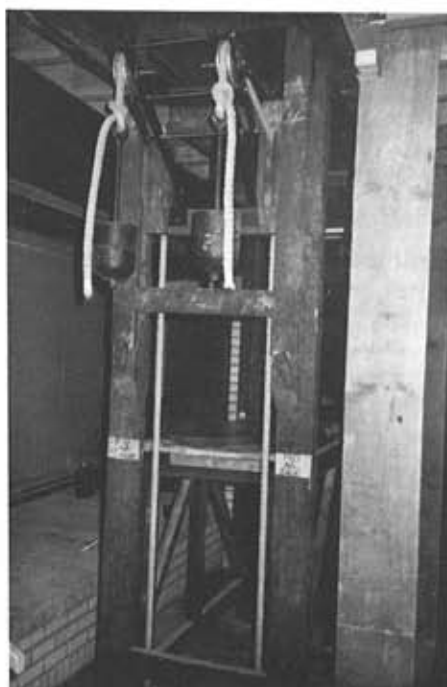
The original coffin trap has been preserved.

To retain the theatricality of the venue, two star traps and a coffin trap (circa 1926) were taken out for refurbishment and then refitted into a revised position. A nice idea, providing no very ancient pantomime performer thinks they are still in the same place!

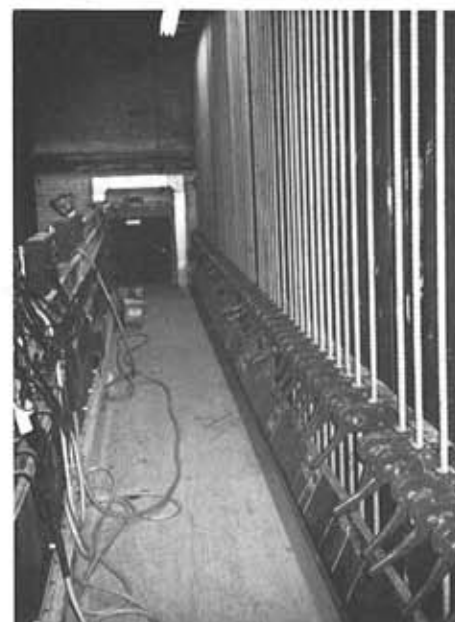
The new operator gallery with re-positioned rope locks - originally at stage level.

A total rebuild of all equipment removed from stage level was undertaken, and the counterweighting operating rail and rope locks were refitted to the new position on the first level bridge, actors left. This involved fabrication of all new steel work and also the installation of full height, full length guards to the counterweight system at stage level.
